# Watershed Scale Approach to AMD Remediation

A dosing trial study was conducted by the National Mine Land Reclamation Center (NMLRC) for the West Virginia Department of Environmental Protection (WVDEP) Office of Special Reclamation (OSR) to determine the effectiveness of in-stream dosing in the Martin Creek sub watershed.

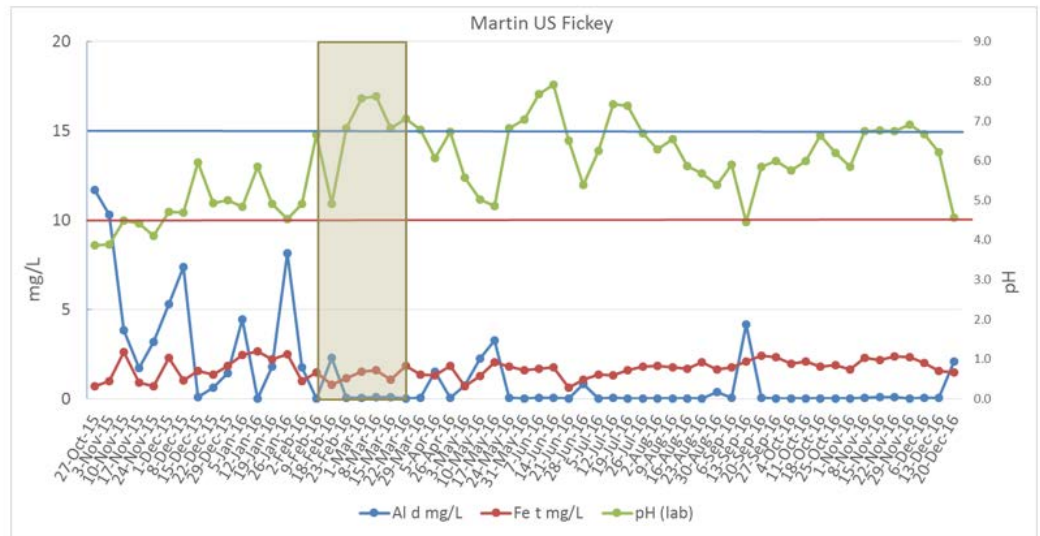
Figure 3. Restoration target performance measured at the compliance point (MUF). The blue horizontal line represents the dissolved aluminum (Al d) restoration target and the red horizontal line represents the total iron (Fe t) restoration target. The shaded area indicates the dates when the Martin Creek at-source dosers were turned off.

The goal of this project was to determine whether in stream dosing could achieve water quality levels consistent with the three restoration targets: pH (3.2 to 9.0), dissolved aluminum (15 mg/L) and total iron (10 mg/L) as determined at the compliance point: Martin Creek Upstream of Fickey Run (MUF). Despite periodic inconsistencies in doser operations, the pH, dissolved aluminum and total iron targets have been met at MUF since initiation of dosing in early November 2015 (Figure 3).

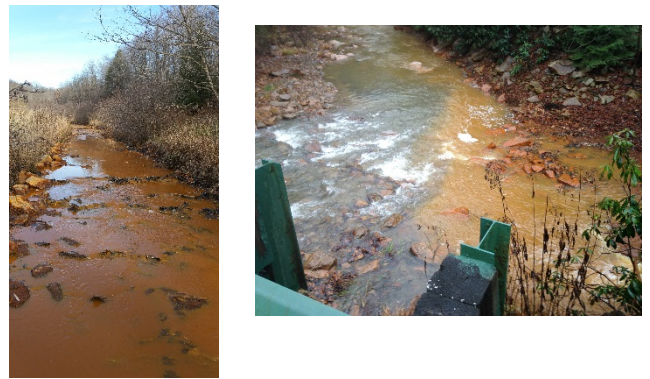
Figure 4. Fickey Run at Dream Mountain (left); Martin Creek entering Muddy Creek (right) on 17 November 2015.

Figure 4 depicts stream conditions when F1 was operational. Total suspended solids (TSS) were measured weekly and showed no correlation with flow (Q) as shown in Figure 5. The tables and below figures show loadings in tons per year (tpy) which are calculated by a formula using concentration (mg/L) and flow (gpm).

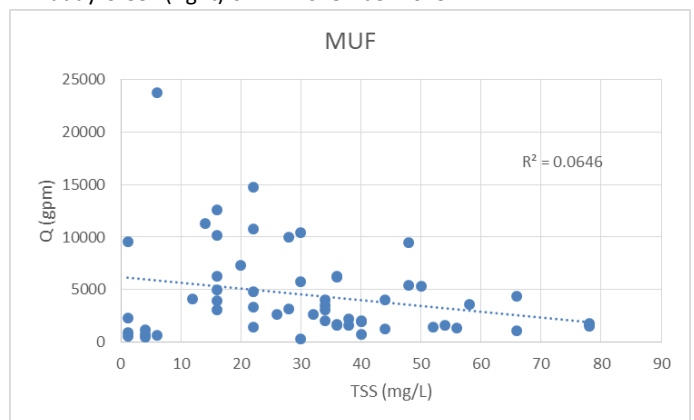
Figure 5. Total Suspended Solids (TSS) and Flow (Q) at Martin Upstream Fickey (MUF) site.
